LAKE SALTONSTALL OUTLET  
MA-00164

NATIONAL DAM INSPECTION PROGRAM  
CORPS OF ENGINEERS

## LAKE SALTONSTALL OUTLET

Identification No.: MA 00164  
Stream: Tributary of Merrimack River  
Town: Haverhill  
County and State: Essex County, Massachusetts

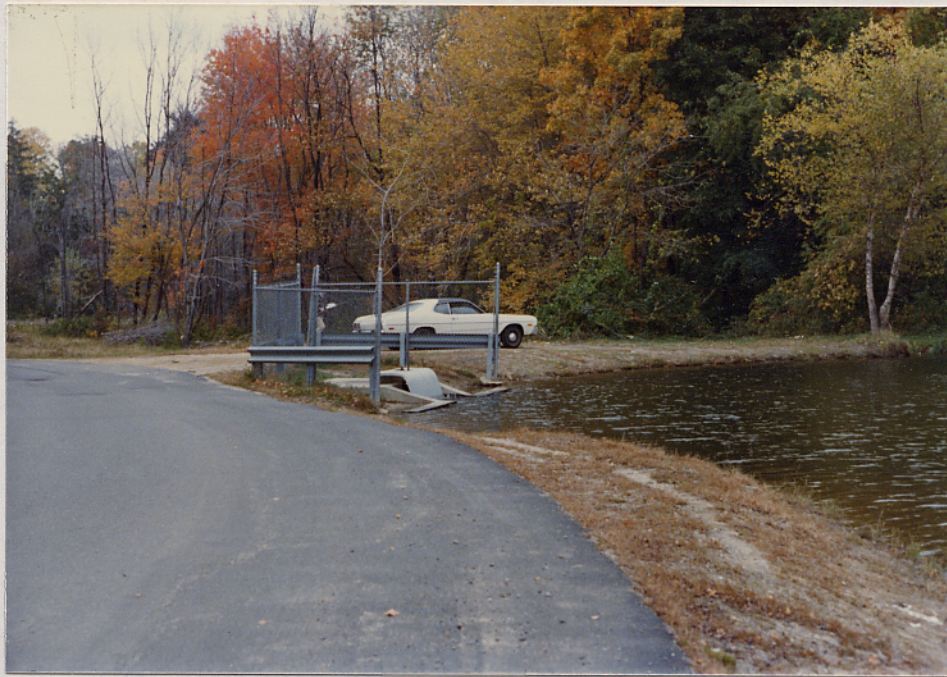
PHOTO NO. 1 - Upstream view of Lake Saltonstall Dam. The intake structure with intake screen, is at the center of the photo. This is the only known inlet. This structure outlets to a drain line in adjacent service road.

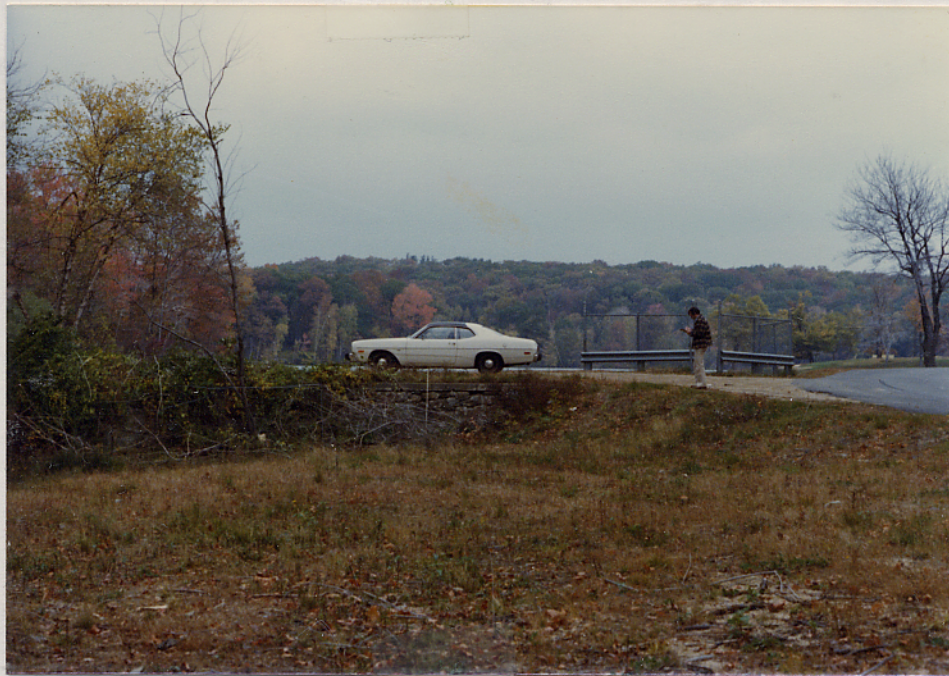
PHOTO NO. 2 - View of downstream face of Dam. The Dam is about 6 ft. high and 80 ft. long. It is an earth embankment, stone masonry structure. The top elevation of the Dam is 121±.

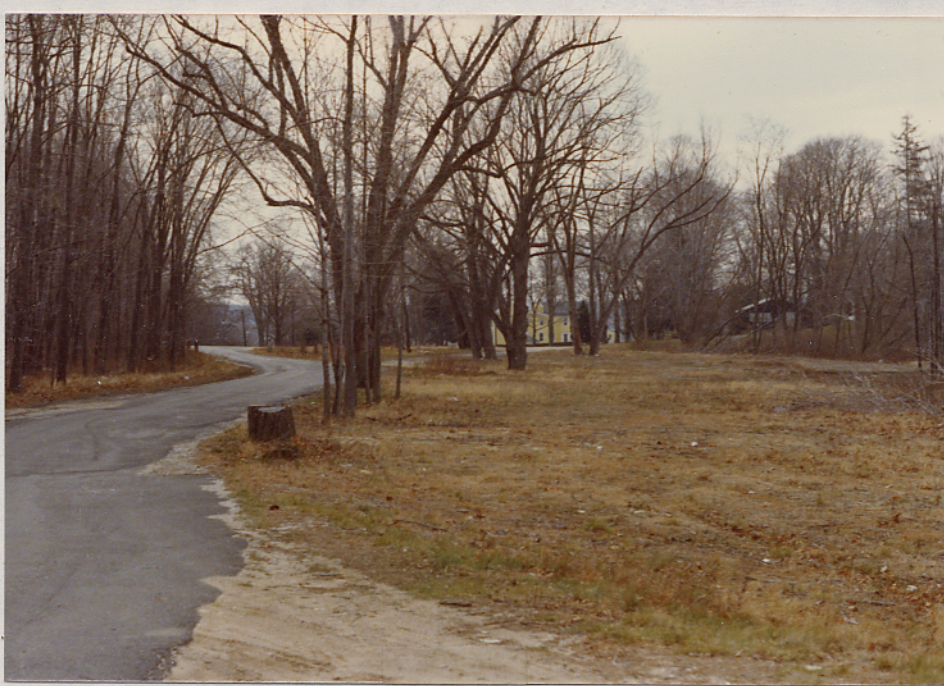
PHOTO NO. 3 - This photo shows the immediate downstream area and service road. The "low" area to the right acts as a retention area. Drainage outlet, if any from this area, is unknown. Mill Street can be seen at the end of the access road. The access road's lowest elevation is 118.67, about 2.33 ft. below the top of Dam, at this location.

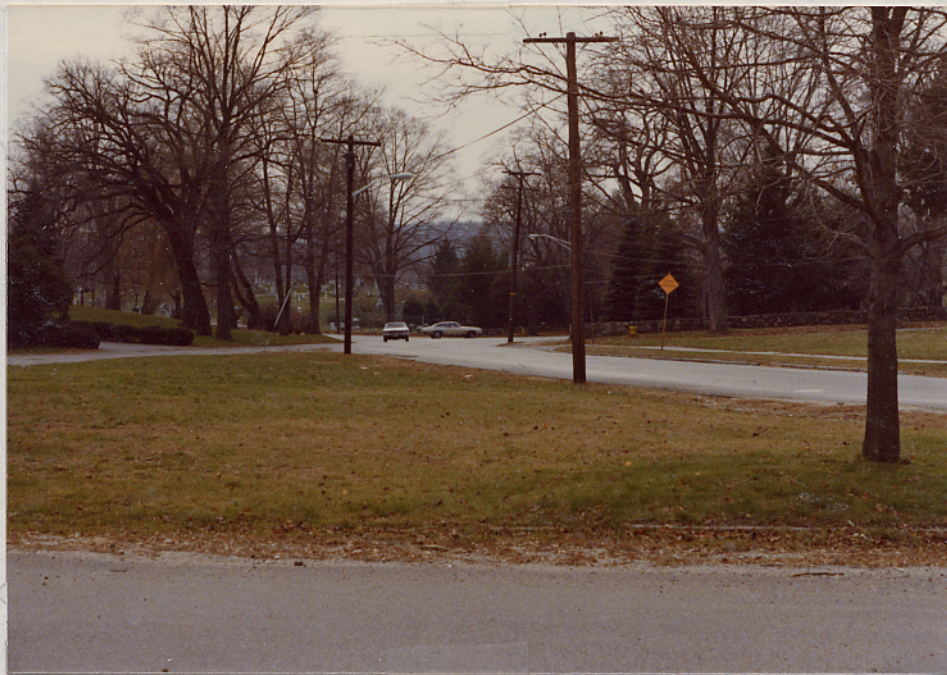
PHOTO NO. 4 - This photo was taken at the intersection of the access road and Mill Street (Sta. 6+00). The elevation of the access road (foreground) is 118.67. The elevation of Mill street at center of photo near location of cars, is 110±. Bordman Street comes into this intersection from the left, near the cemetery. Flood depth in this area will be about 1.2 ft. All inhabitable structures are above this level.

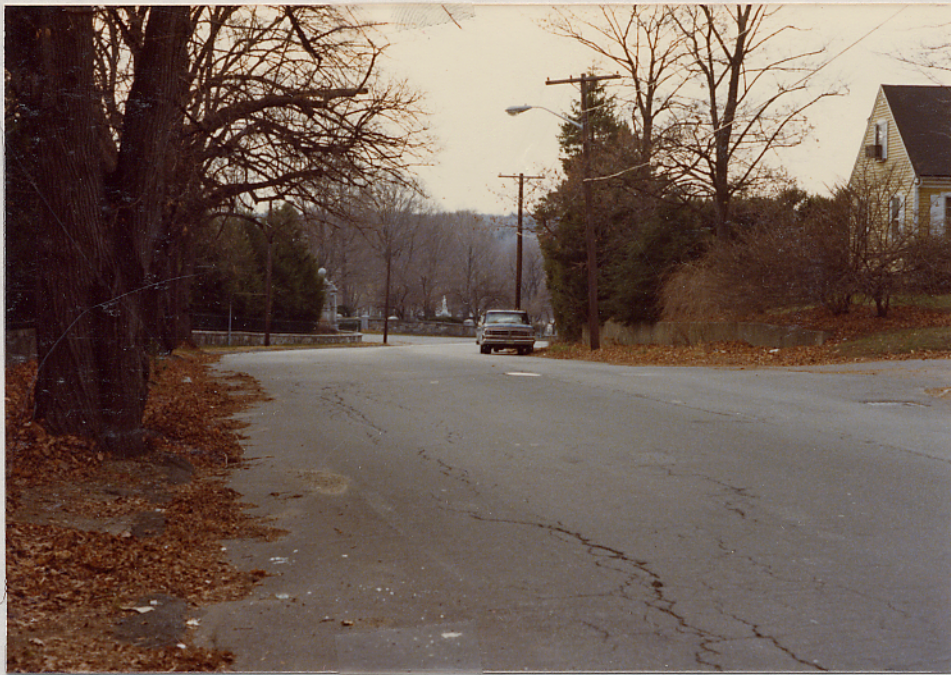
PHOTO NO. 5 - This photo was taken at the intersection of Mill and Bordman Streets (Sta. 11+00). It was taken looking south along Mill Street. All habitable structures are above the street level by several feet. Flood depth here is about 0.75 ft.

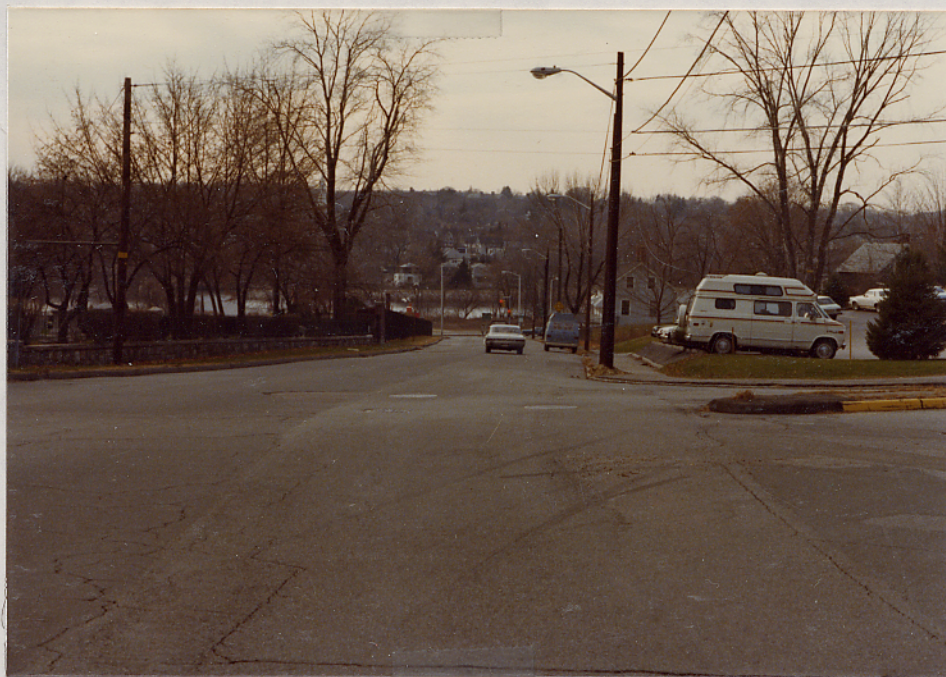
PHOTO NO. 6 - This photo (Sta. 16+00) was taken at Mill and Summer Streets. Here again, there are no habitable structures within 3 ft. of the road level. Flood depth is about 0.75 ft. The intersection at Route 97 (Sta. 24+00) and the Merrimack River (Sta. 26+00) can be seen at the center of the photo.

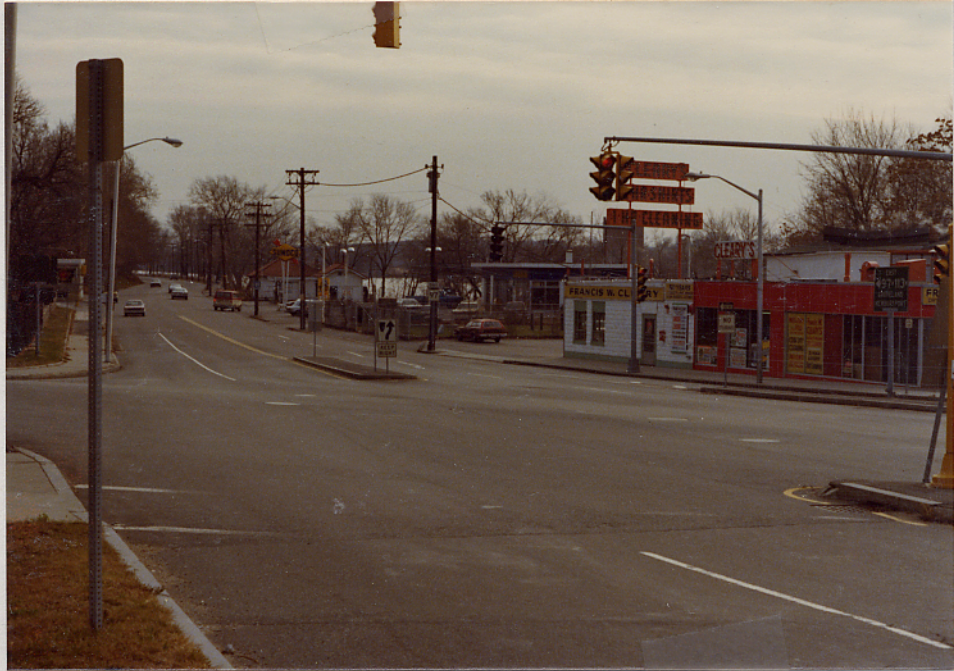
PHOTO NO. 7 - This shows the intersection of Route 97 and Mill Street, looking to the east. River Street enters from the right side. Water depth here will be 0.75 ft. and less as it begins to flow onto Route 97 and River Street. Flood damage at these structures would be limited to some flooding of first floor areas. Possible loss of life not indicated as flood water depth should be reduced to 6 inches or less as the flood water impact area increases.
